# Michigan Central Station

*Transformation of an Icon*

DETROIT, MICHIGAN

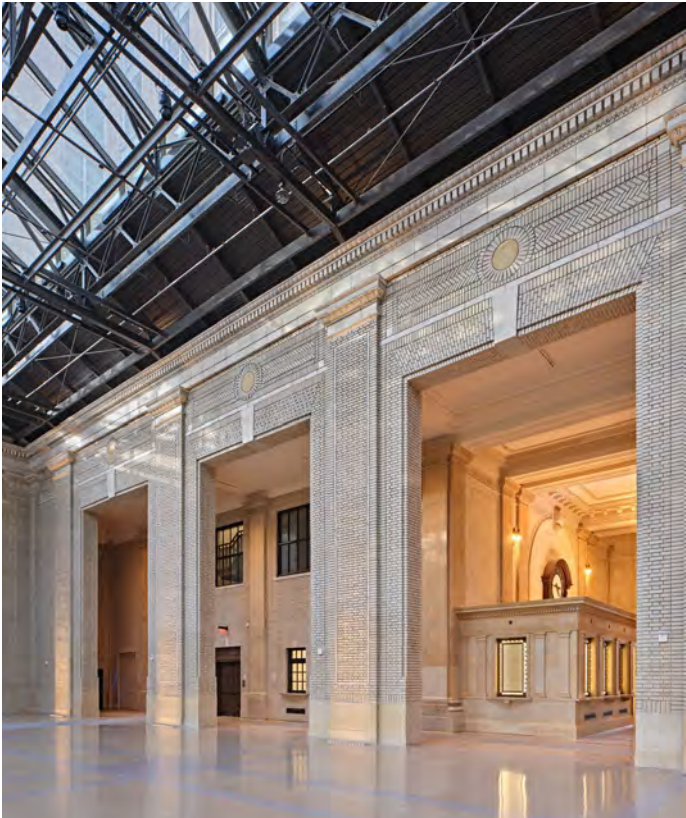
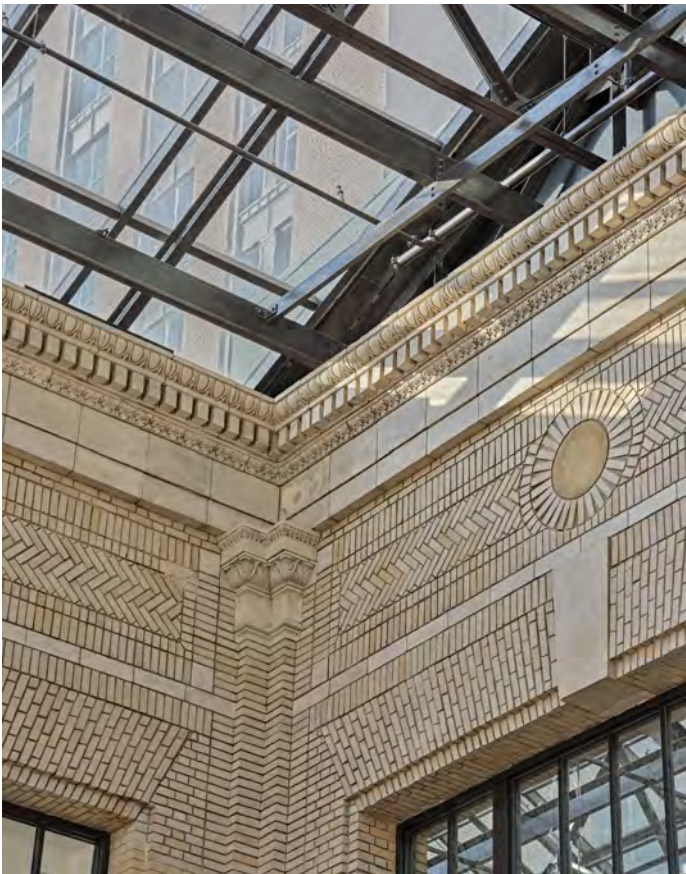
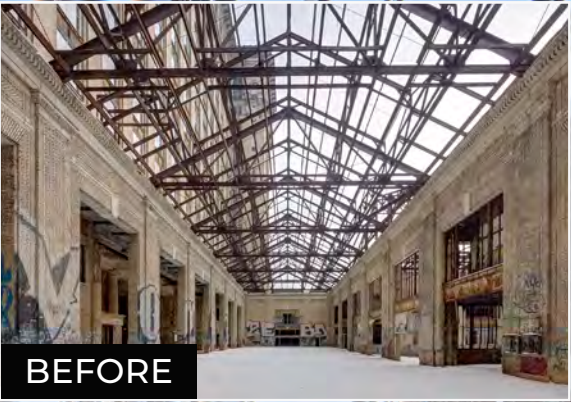
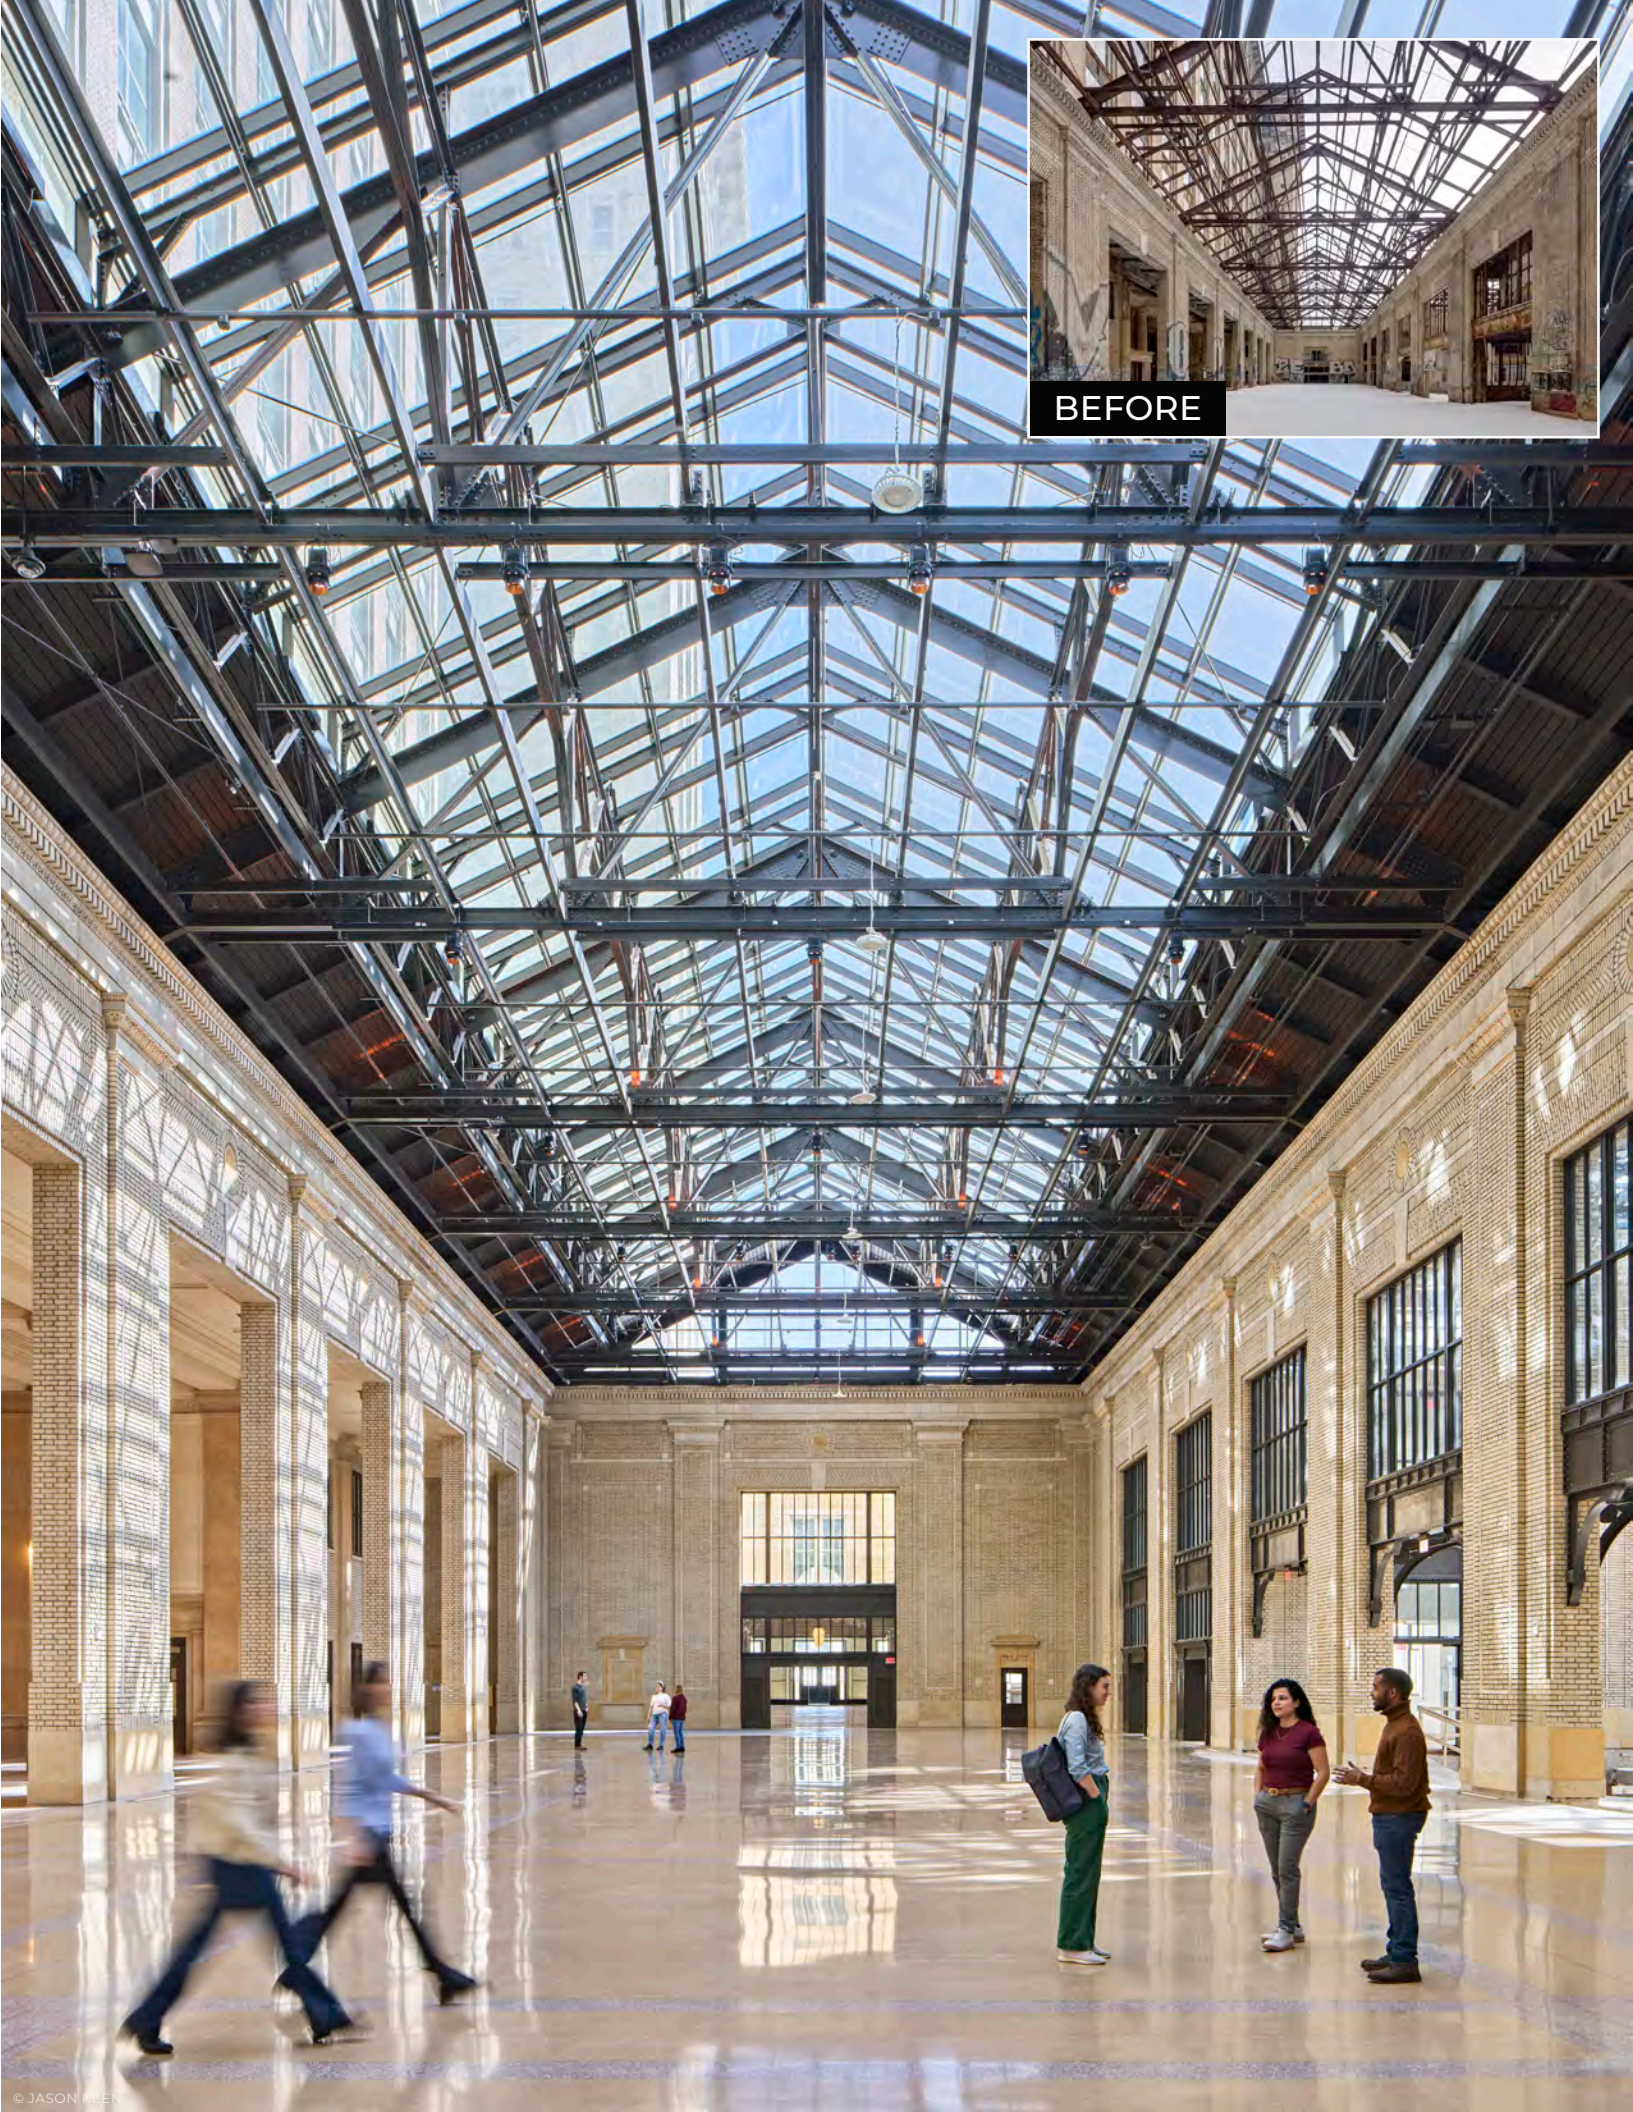
# CONCOURSE

- **Skylight:** The Concourse was historically capped with a laylight. After years of being open to the elements (in the “before” picture, the floor is covered in snow), the Concourse now features a skylight—keeping the roof truss system exposed, as it was when the building was vacant.
- **Original Elements:** All the brick and terracotta details in the Concourse, along with the cast iron spandrels, are original and were restored.
- **Flooring:** The original terrazzo floor had deteriorated beyond repair. Its replacement includes an in-floor radiant heating system.

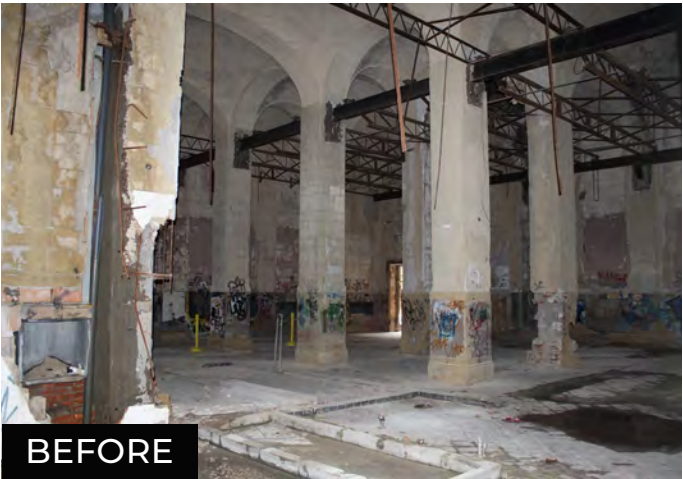
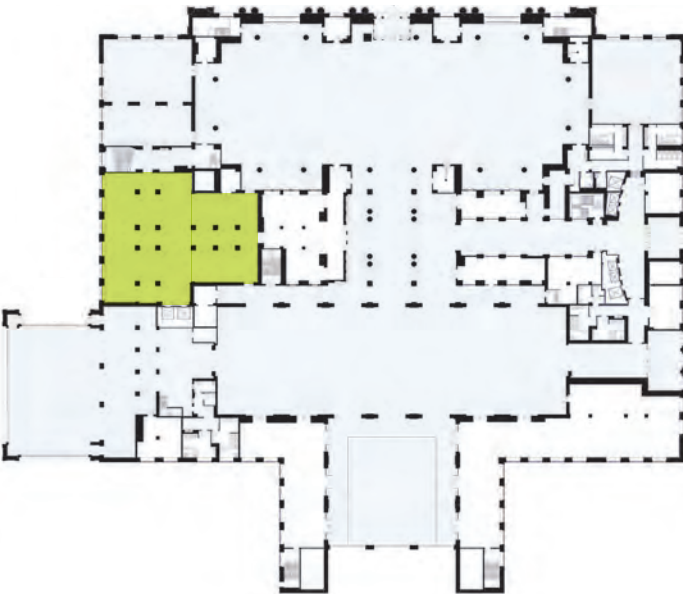
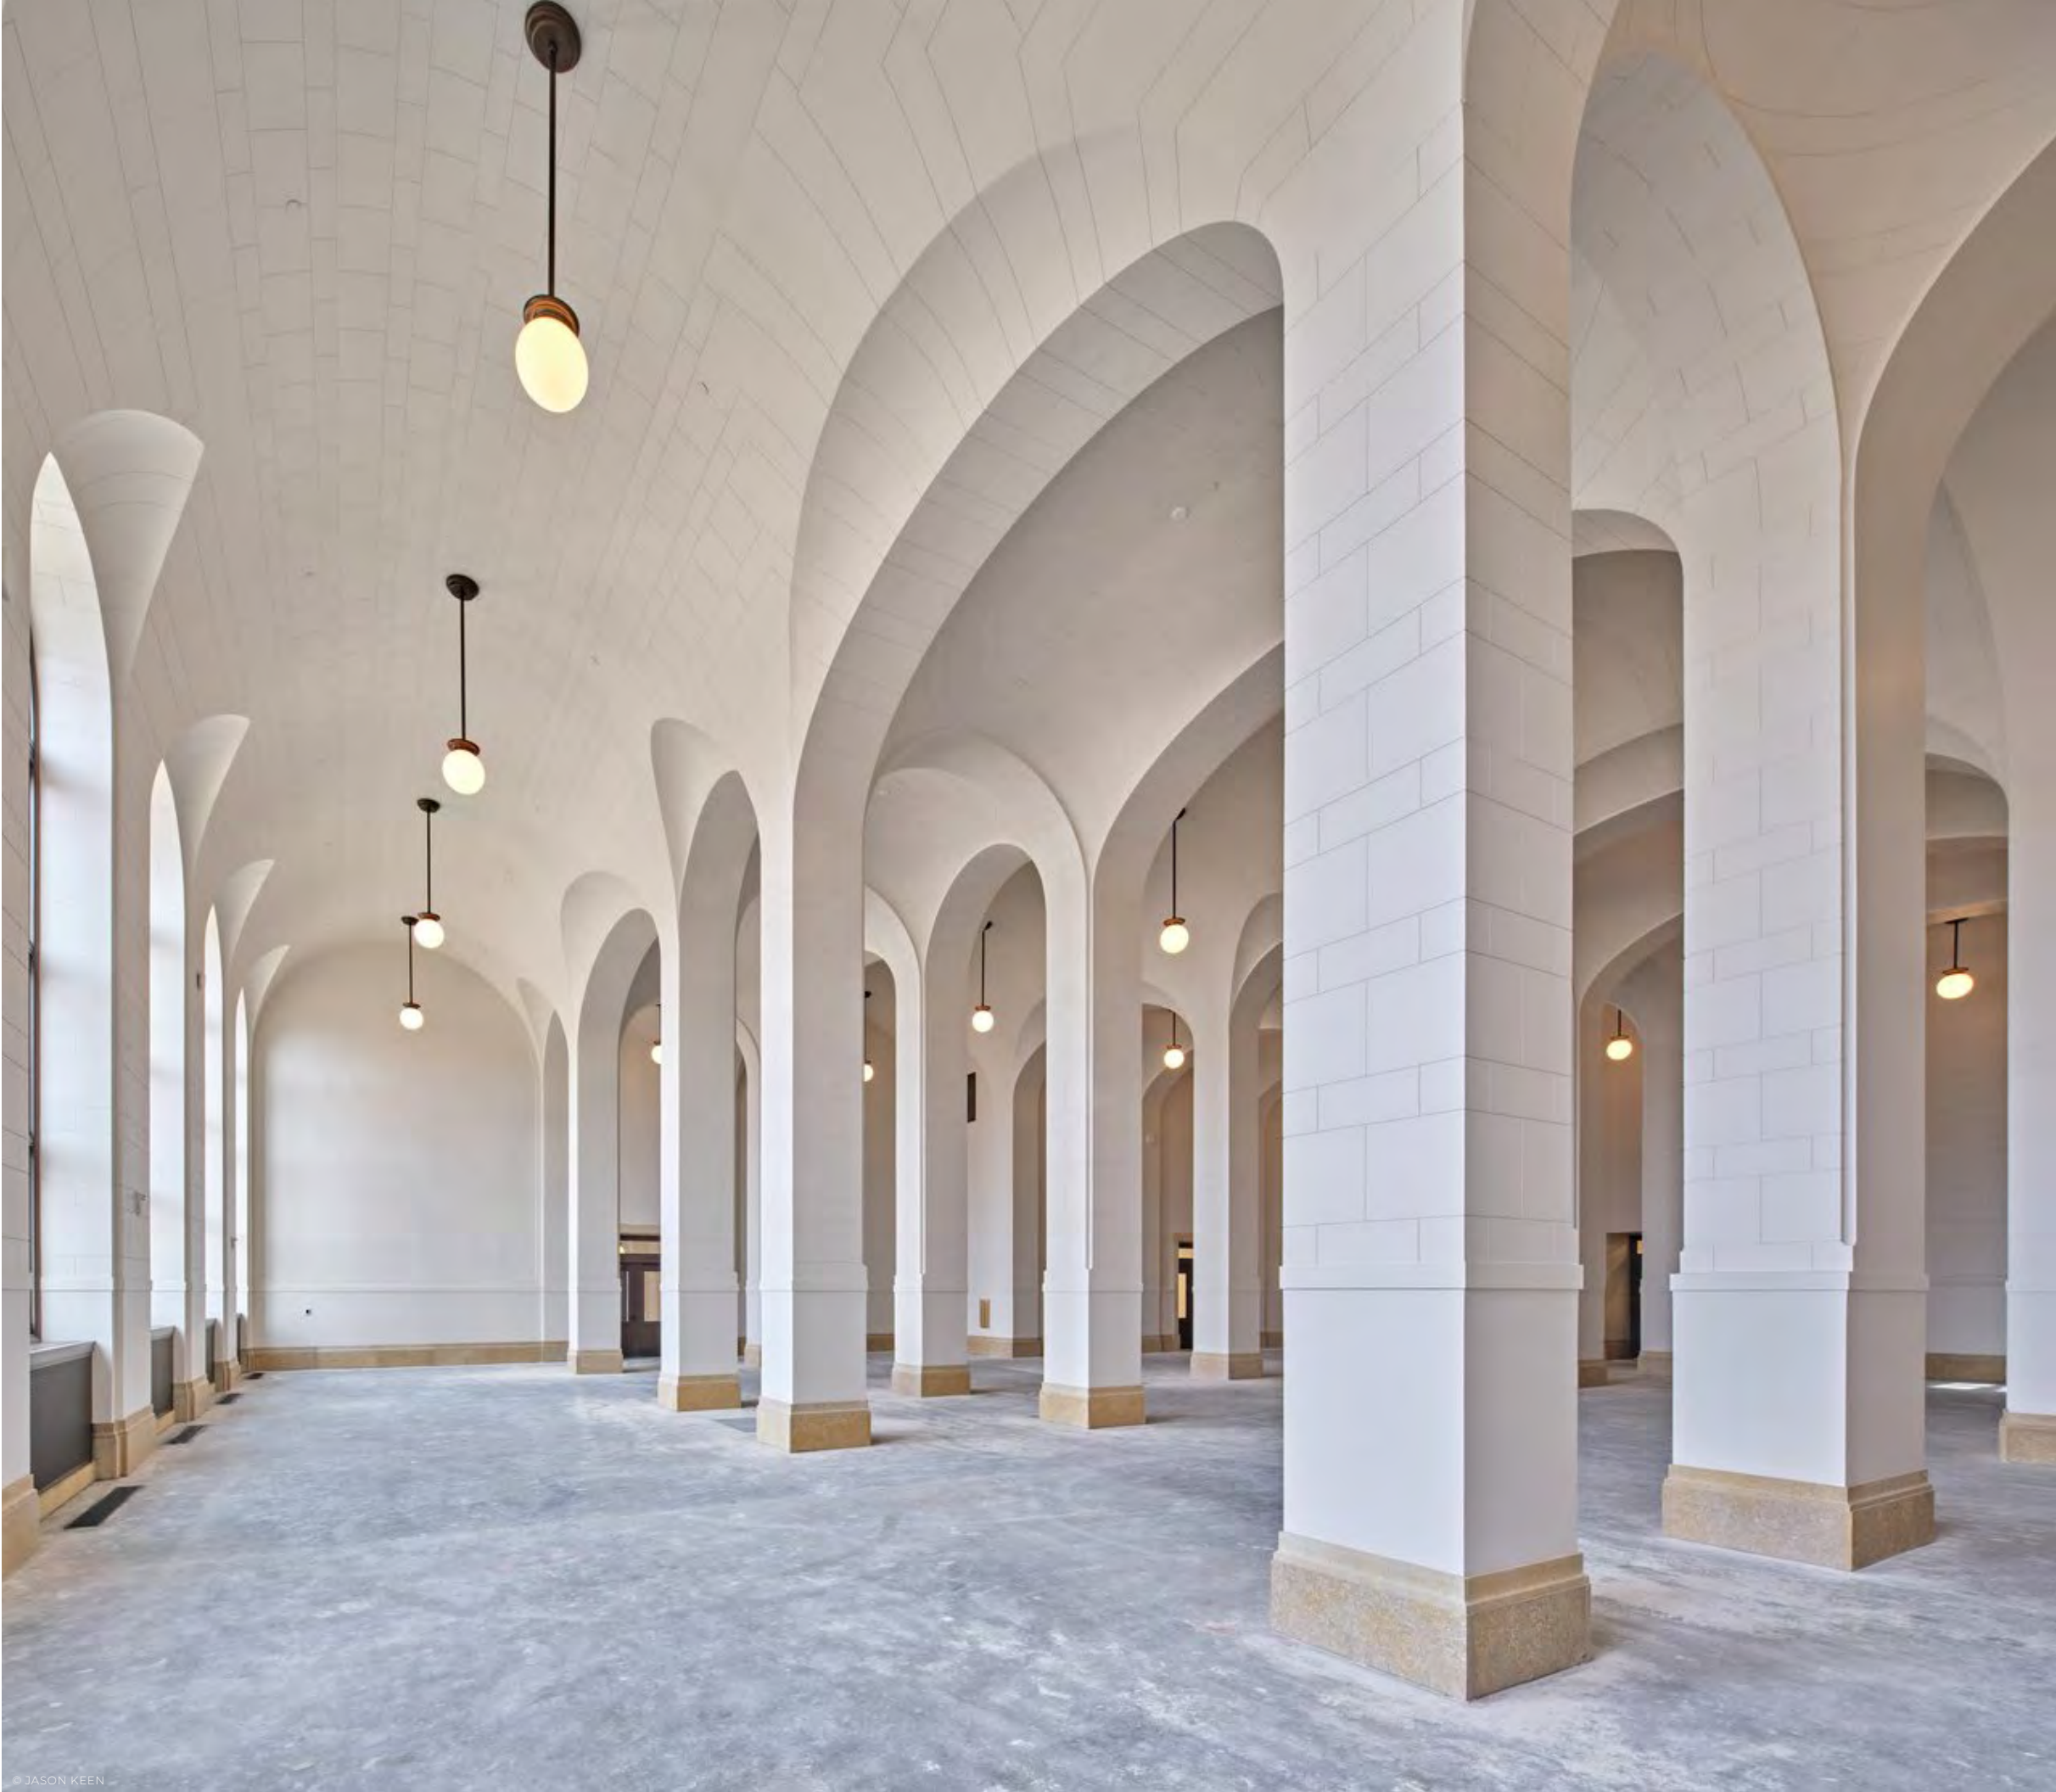
# RESTAURANT

**Vaulting:** The original plaster vaults, which were textured to look like stone, were replicated.

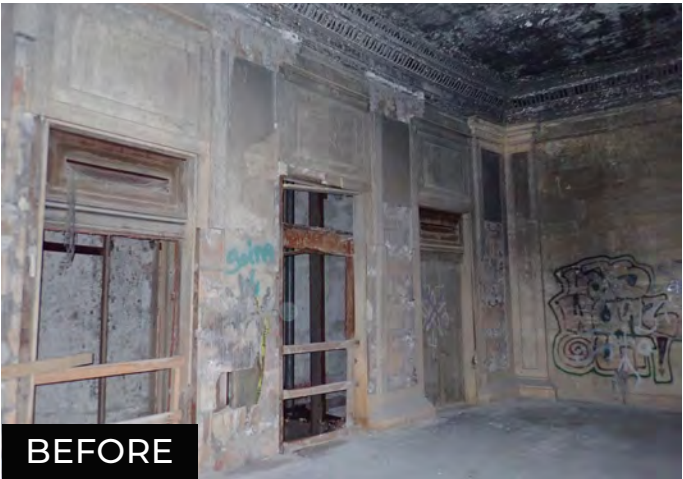
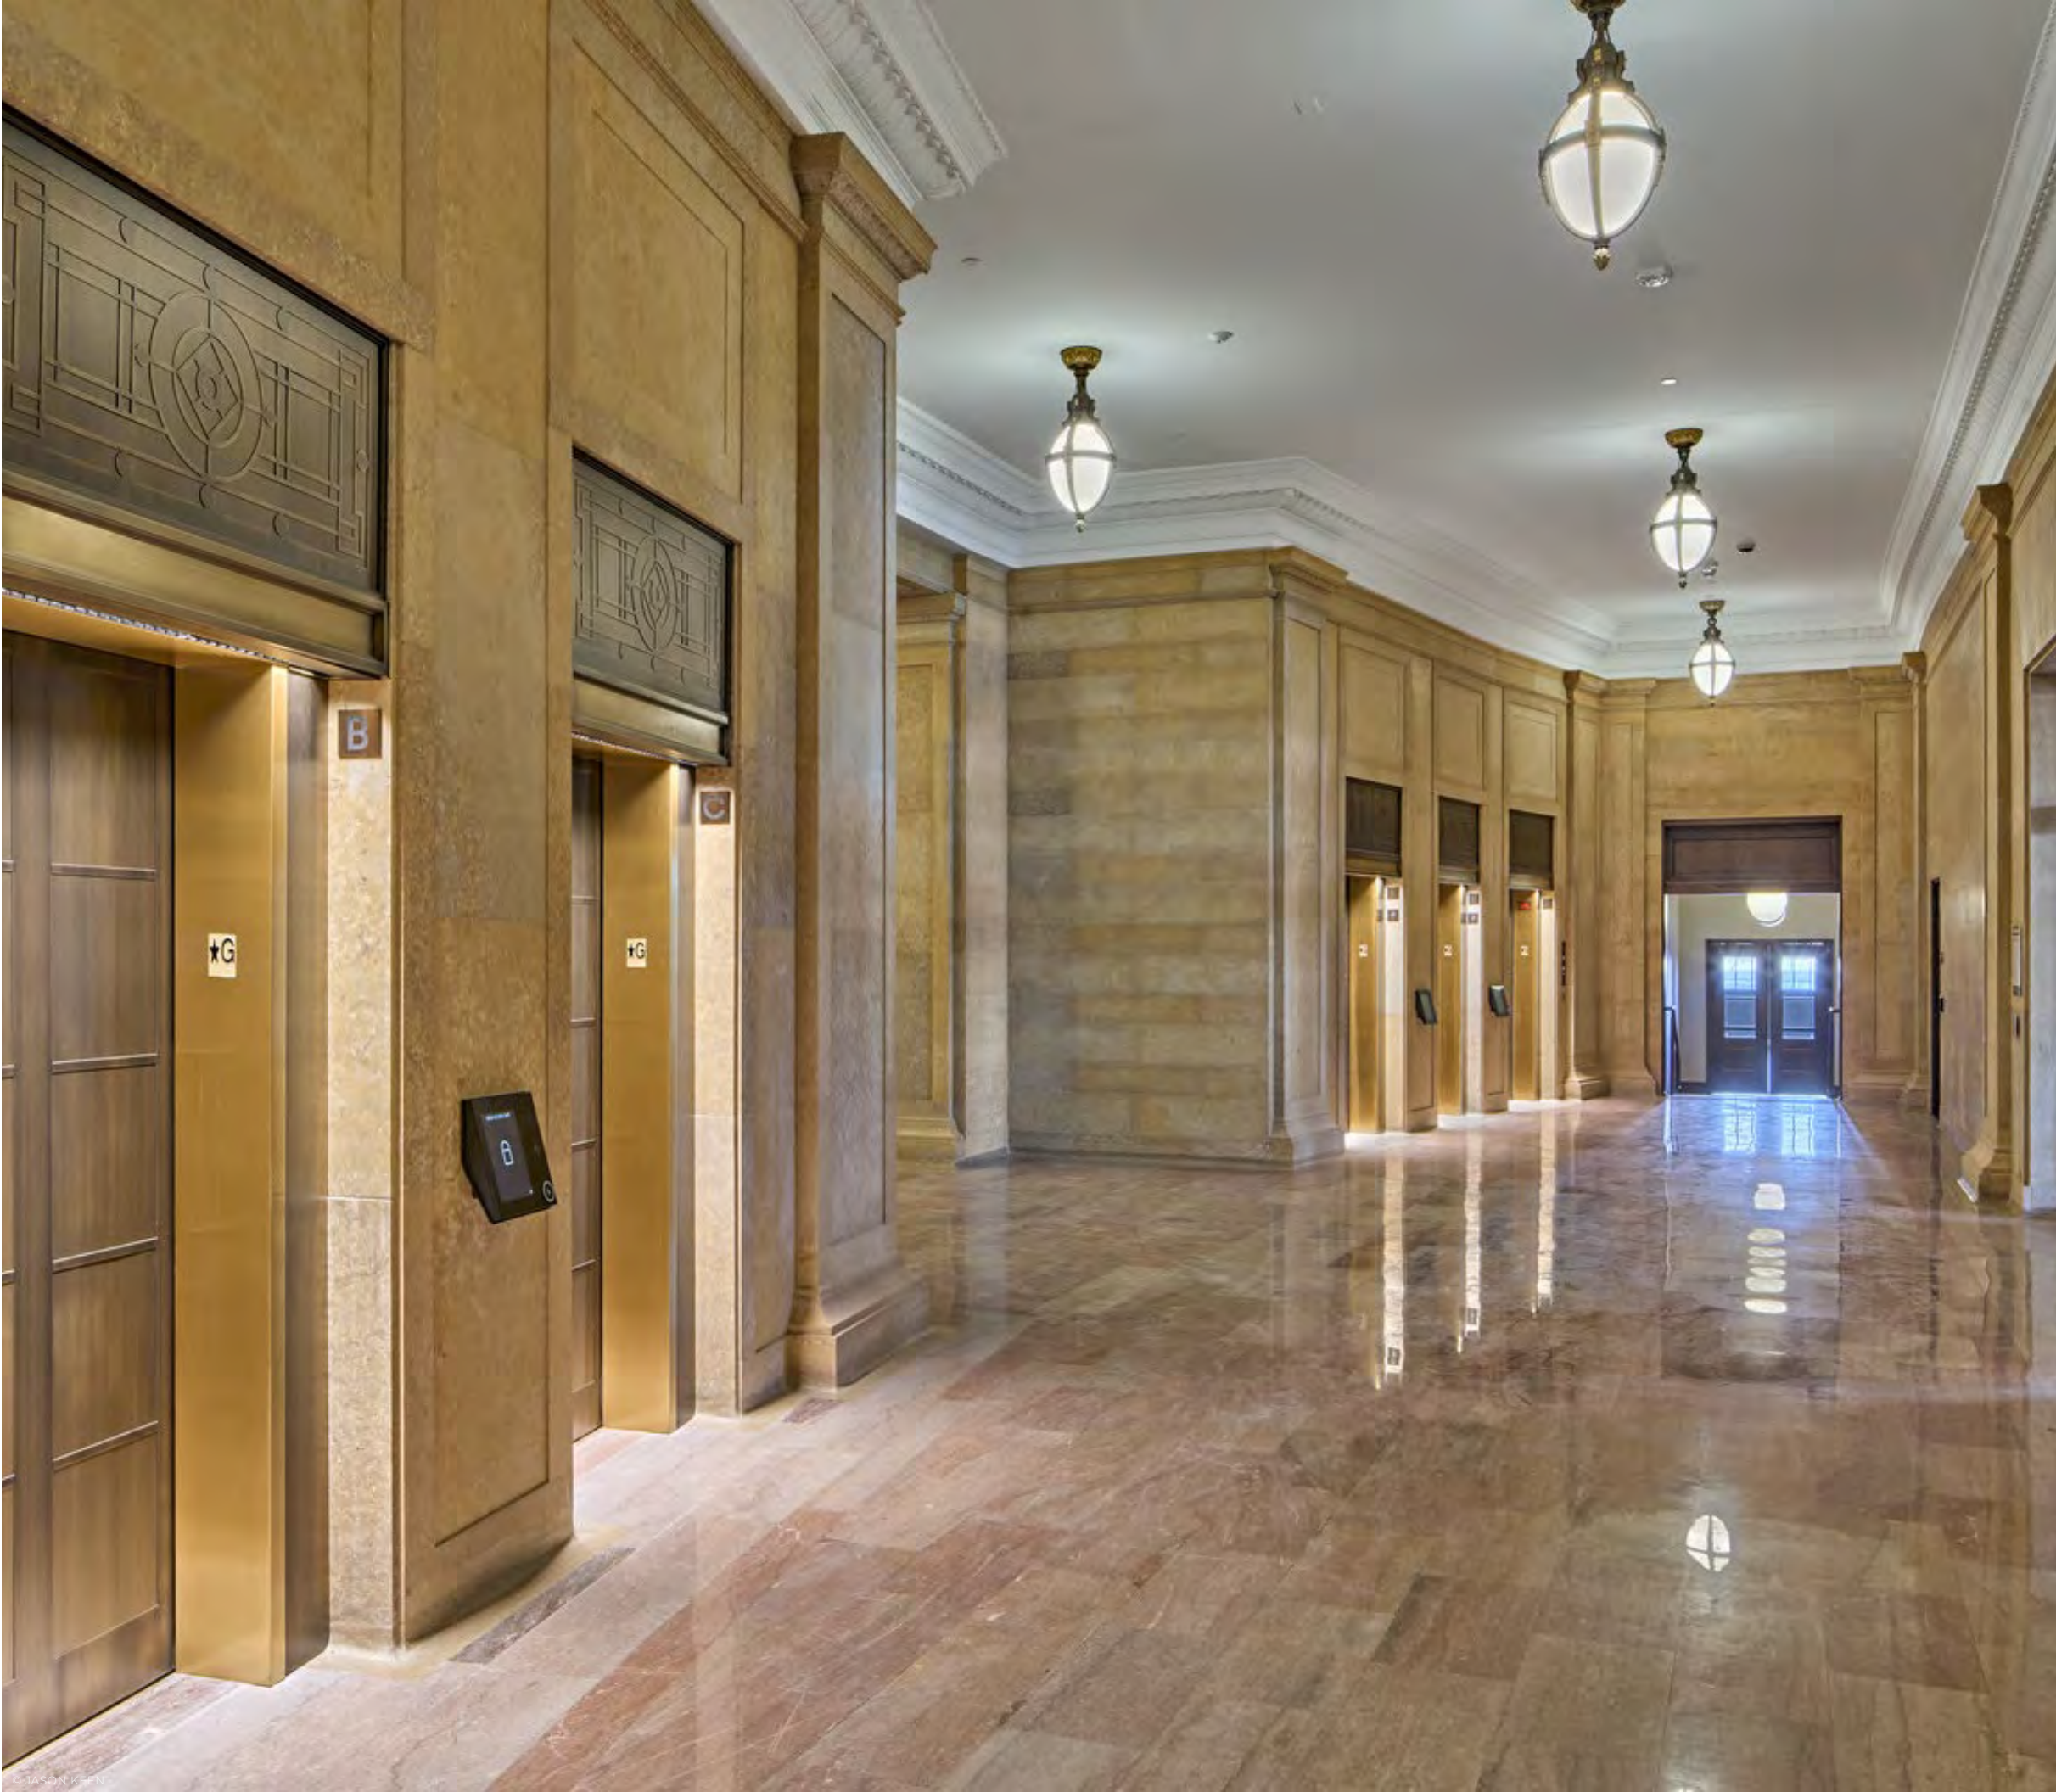
# ELEVATOR LOBBY

- **Walls and Floor:** The Elevator Lobby is clad in Mankato stone and features a restored marble floor and plaster cornice.
- **Metal Elements:** The metal transoms and elevator door detailing reflect the original dial floor indicator and divided lite panels.
